NEW MEXICO  
ENVIRONMENT DEPARTMENT

**Memorandum**

**Subject:** Pre-CERCLIS Screening Assessment of the Section 12 Mine  
(Grants Mining District), McKinley County, New Mexico:  
Further action under CERCLA recommended

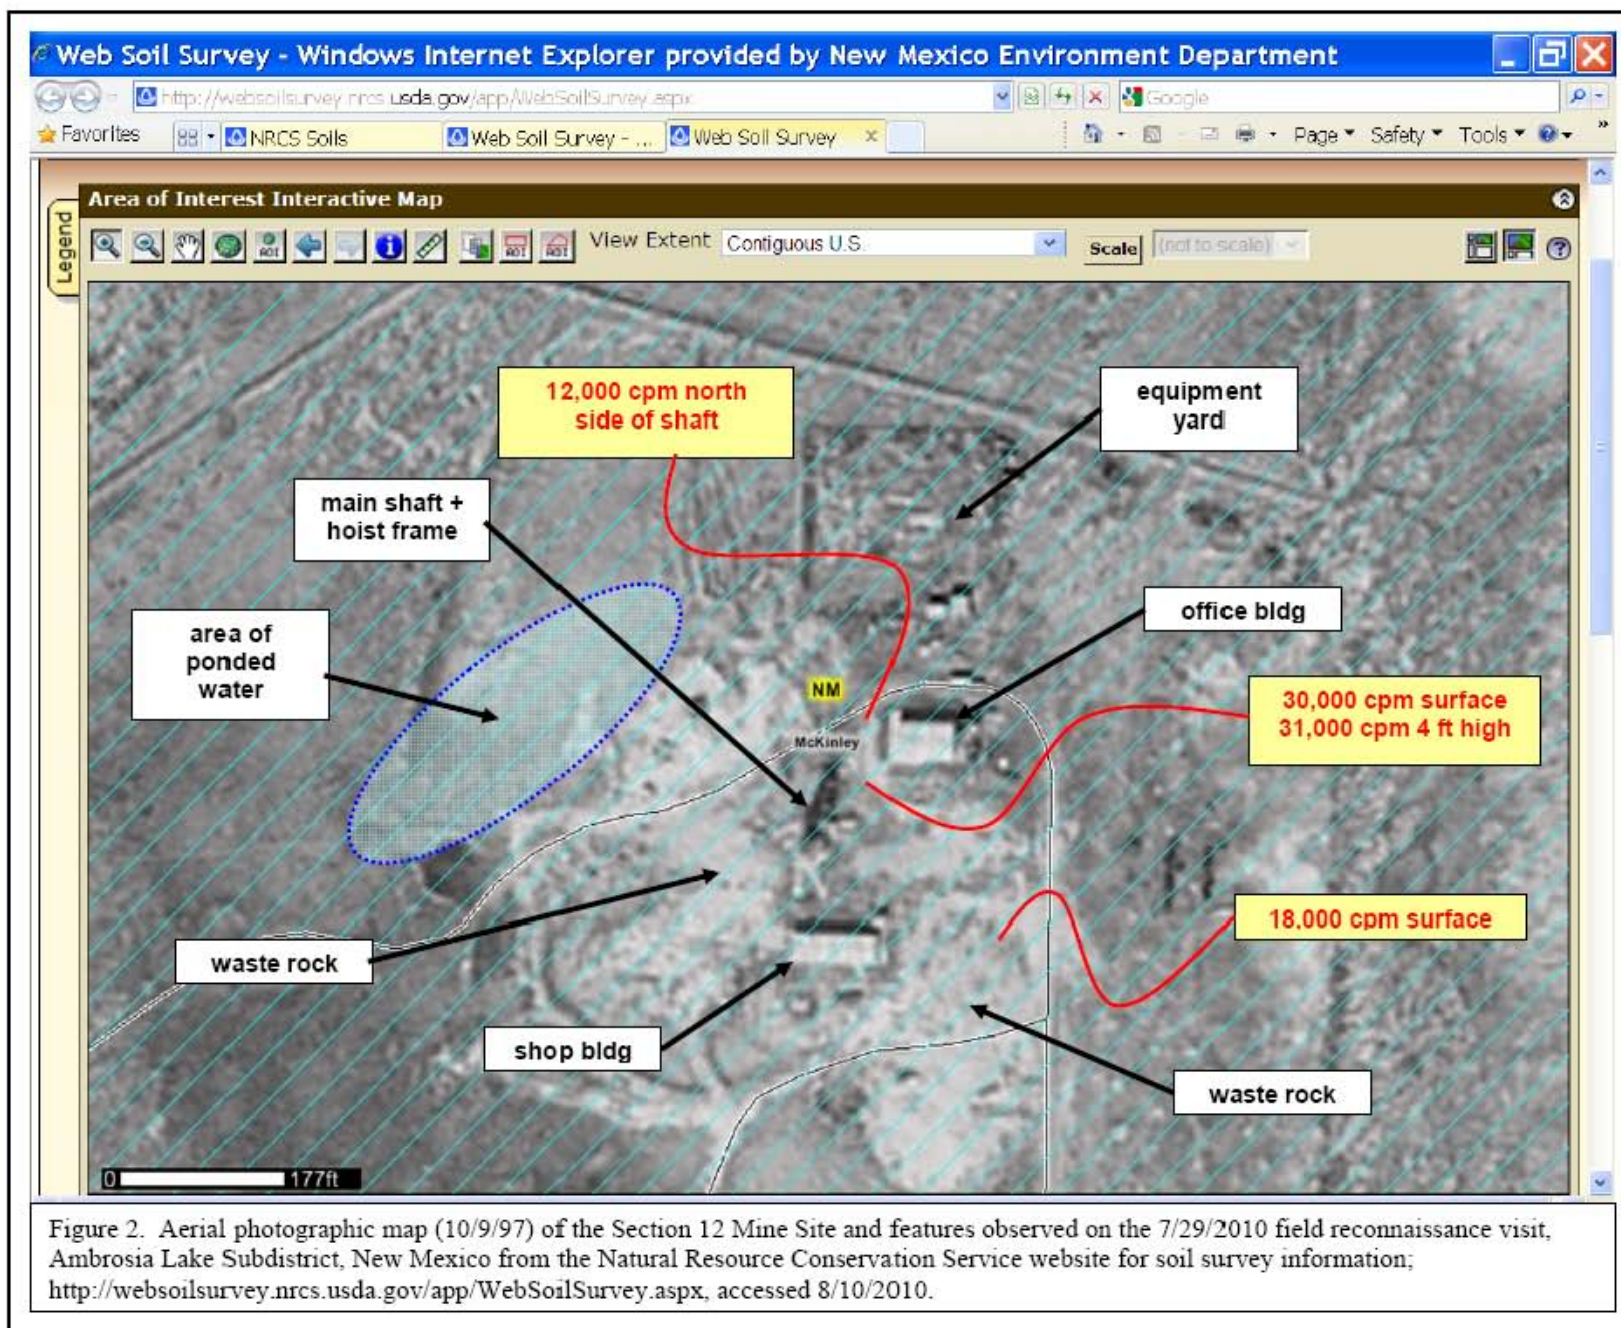
Access to the Site is required by permission from the mineral rights permittee, Mr. George Lotspeich, president of Southwest Resources, Inc. of Albuquerque, New Mexico. Figure 1 is a location map and Figure 2 is a site features map. Figures 1 and 2 are contained in Attachment A.

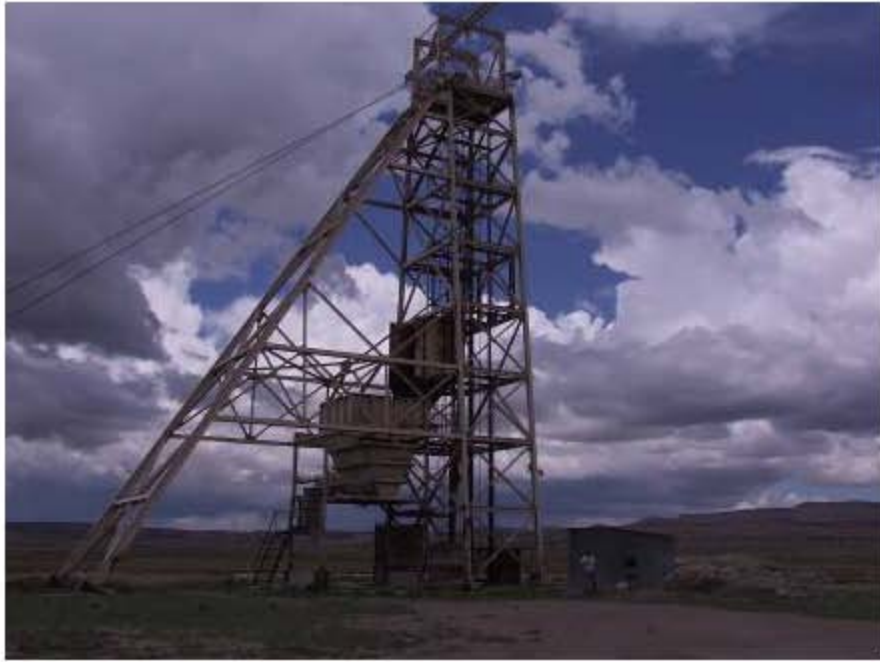
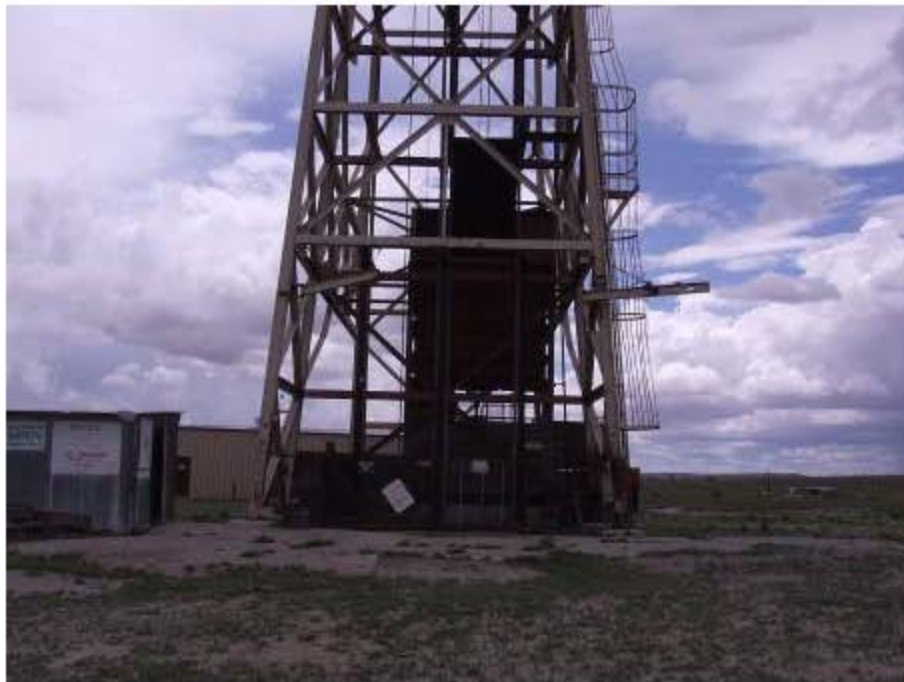
There is a 30-foot high hoist frame structure with a large sheet metal hopper above the sealed mine shaft. The mine shaft is covered with wooden timbers and concrete sections. The hoist control shack is also present. The one story mine office building is located to the northeast of the shaft, and it is approximately 100 feet (ft) long X 40 ft wide. An equipment yard is located on the north side of the office building that is approximately 177 ft long X 177 ft wide. A shop building is located south of the main shaft and it is approximately 80 ft long X 20 ft wide. No pits or open cuts were found at the Site. The area contains noticeable waste rock piles that are over 100 feet long and several feet high. Photographs 1-6 from July 29, 2010 site visit are contained in Attachment B. Currently, underground access to the Section 12 mine is through the Section 11 (Dysart #2) mine shaft which is an air shaft for Section 12. Another air shaft structure and pipe is located approximately 400 ft NNW of the main shaft. There are two other vent shafts on the property. The Section 12 main shaft is approximately 700 ft deep.

Photographs Section 12 Mine: No. 1, main shaft and hoist structure (view from east looking west) and No. 2, main shaft with lower part of hoist visible (view from north looking south).

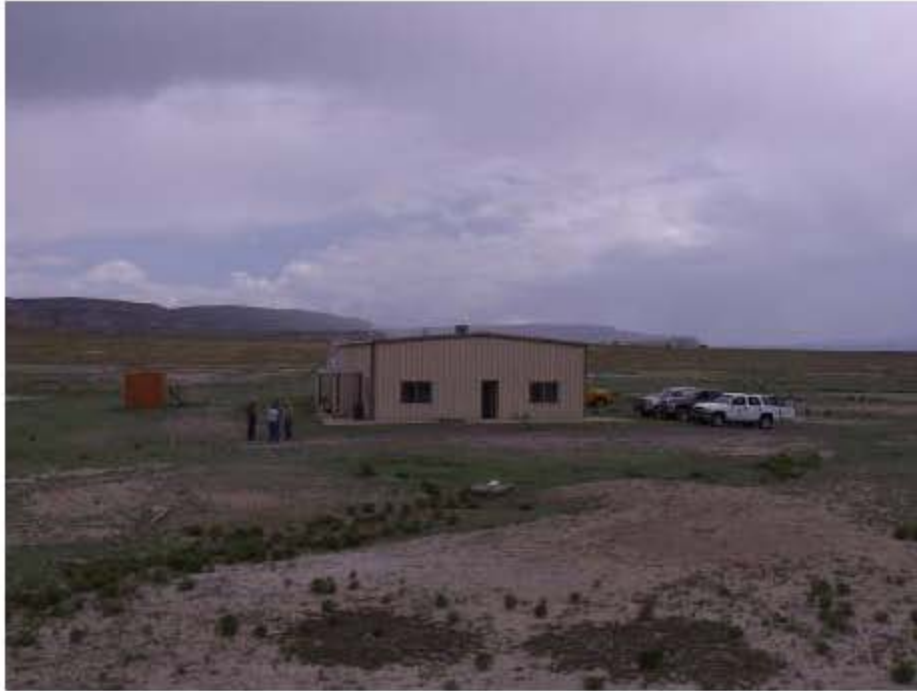
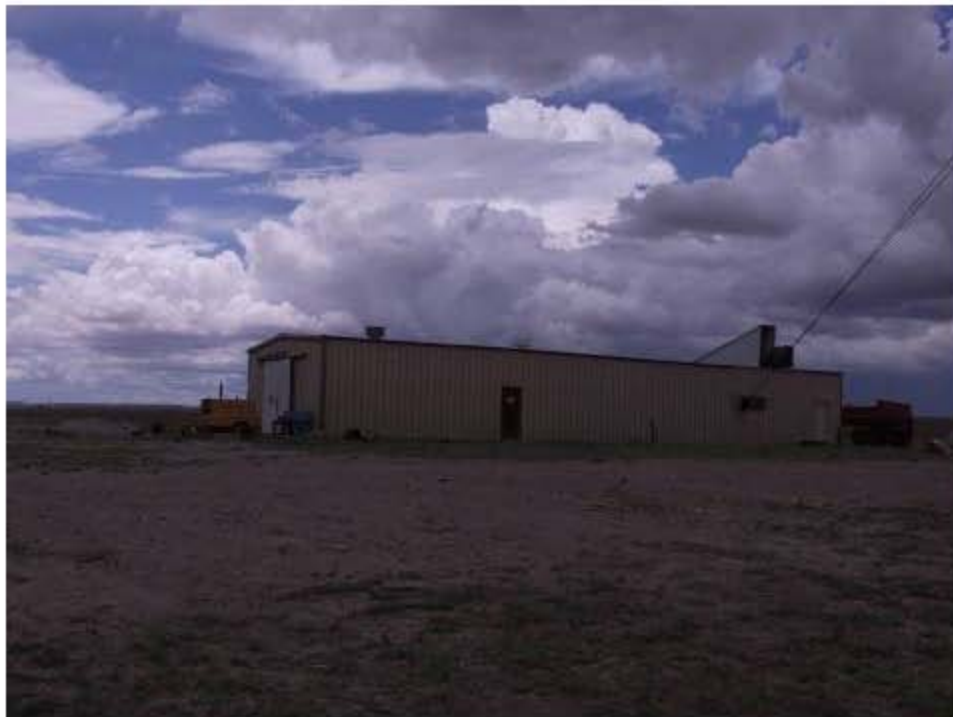
Photographs Section 12 Mine: No. 3, office building (view from waste pile looking east) and No. 4, shop building (view looking south).

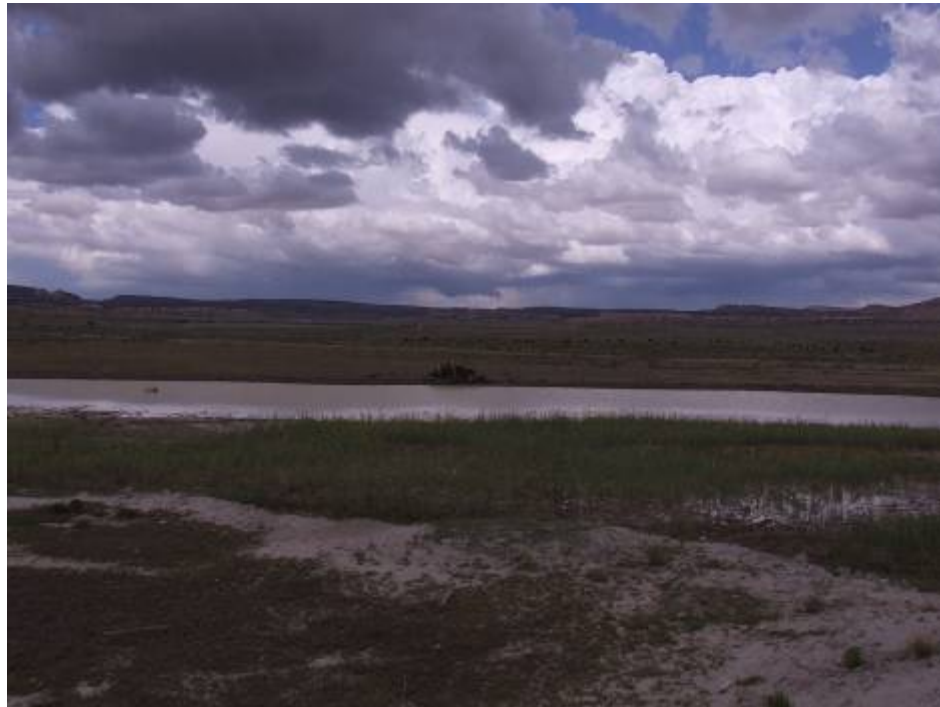
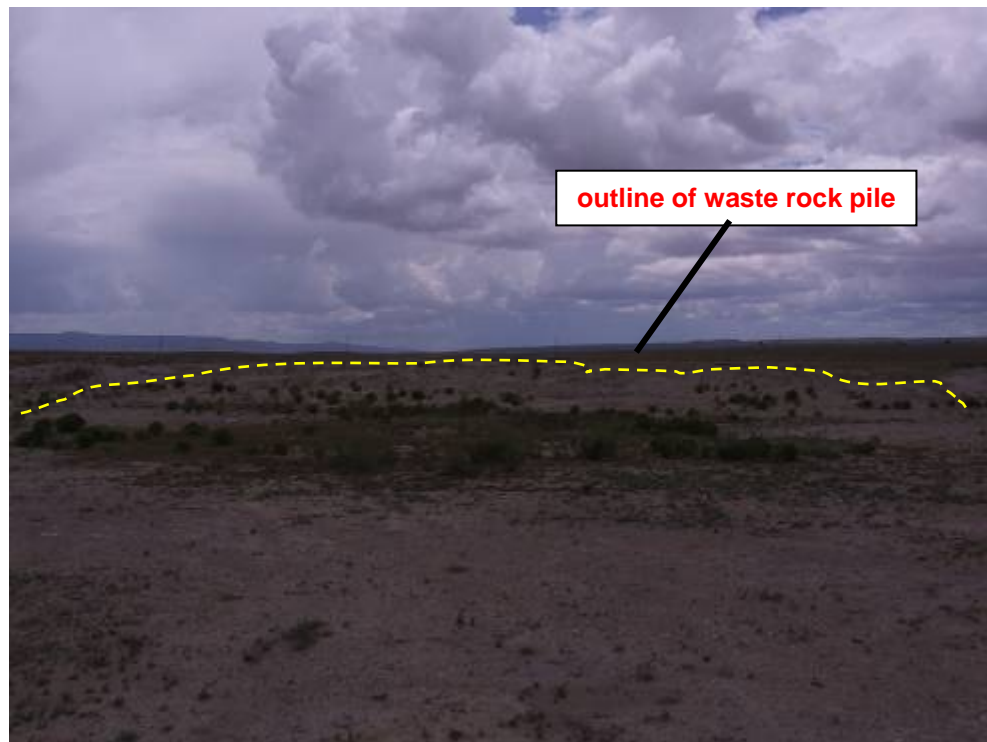
Background readings for the Section 12 area are generally less than 5,000 cpm and more commonly about 3,000 cpm. The gamma readings for the Site ranged from a low of 7,000 cpm (40  $\mu$ R/hr) at the surface of the concrete side walk on the west side of the office building to a high of 100,000 cpm (571  $\mu$ R/hr) at the surface and 80,000 cpm (456  $\mu$ R/hr) at 4 ft over by some waste rock on the east side of the north trending main access road. Waste rock piles averaged about 40,000 cpm (228  $\mu$ R/hr).

Photographs of Section 12 Mine: No. 5, ponded surface water on west side of Site (aka Ambrosia Lake) and No. 6, waste rock pile on south side of Site.
